# RLOP HNC E-1411 Flange Leak and Delayed Plant Start-up

IMPACT ERM Loss #36512  
Investigation #22506

Incident Date: April 26, 2012

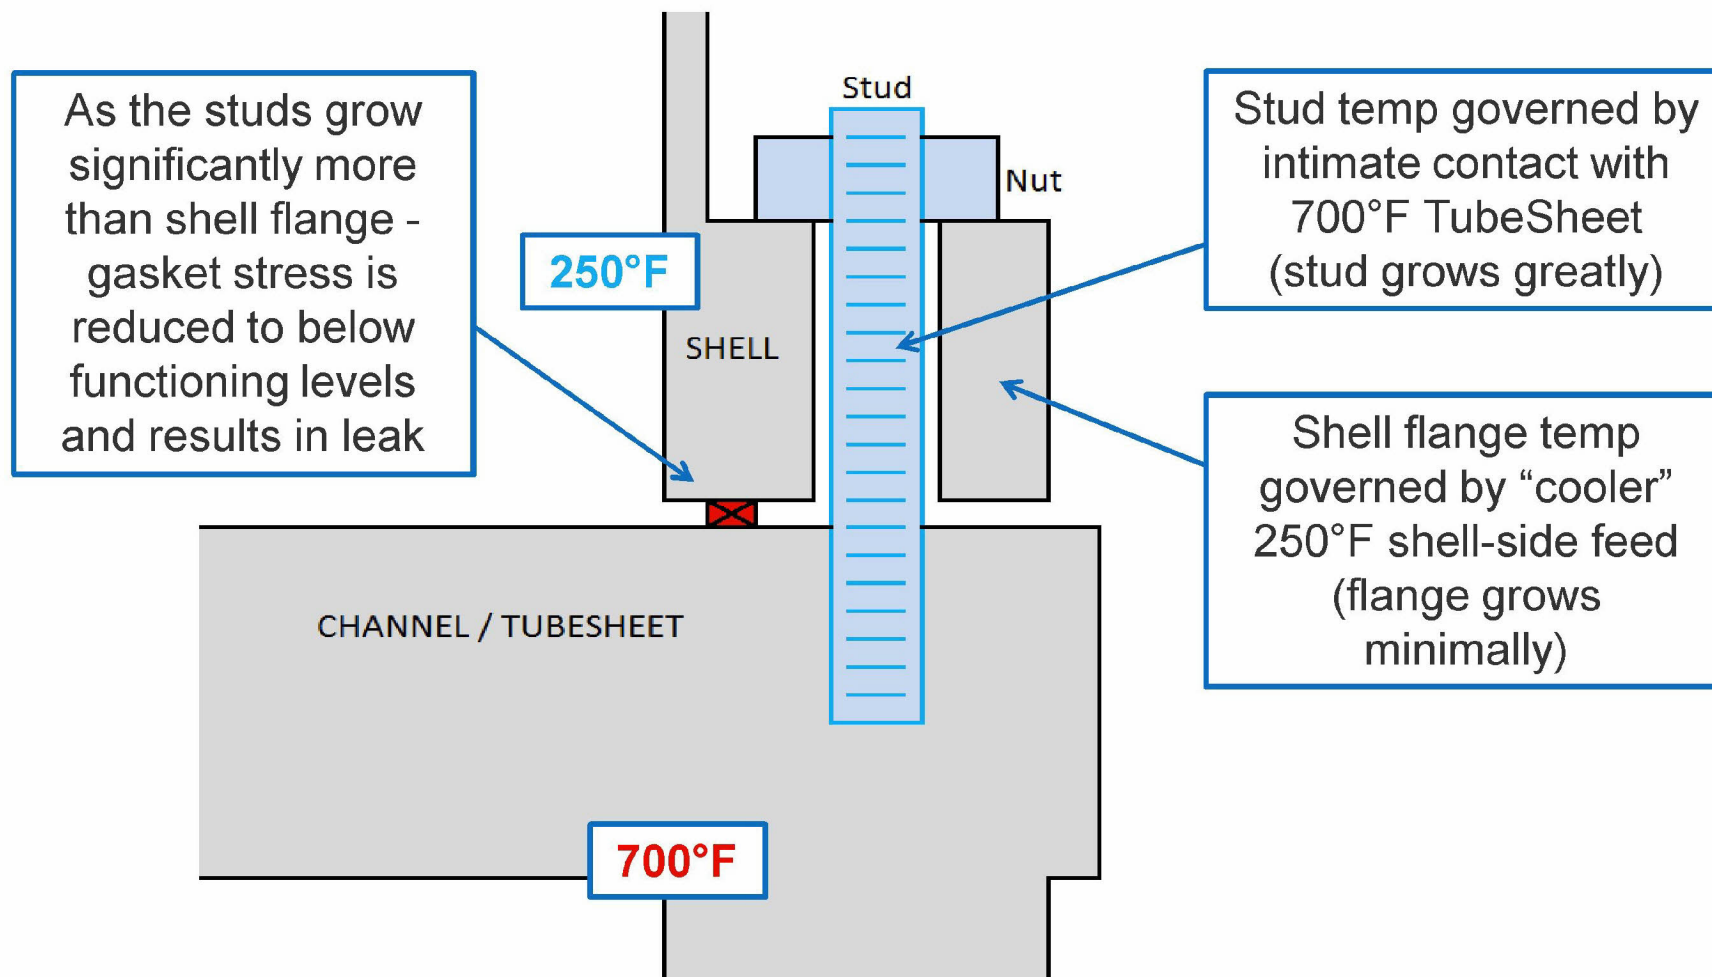
## E-1411 Flange Details

- What happened
  - No-flow conditions on E-1411 shell-side created large temperature differentials between cold shell and hot tube-side. These differentials create closure component differential growths that can significantly unload the gasket
- Why it happened
  - Operations desired to lower feed temperatures to allow for hot strip and subsequent Plant start-up.
- Proposed Solution
  - Recognize that unusual plant postures can create previously unexpected design conditions for E-1411 bolted closure, and design for such.

- What happened
  - When originally developed, the E-1411 closure procedure did not consider the extreme temperature differentials which occurred between shell and channel.
- Why it happened
  - "No flow on shell-side" operating scenario was not anticipated as a likely event.
- Proposed Solution
  - Re-evaluate E-1411 closure procedure while considering the extreme temperature differentials that can occur in unusual operating situations.

- DED to develop E-1411 closure procedure which considers the extreme temperature differentials which can occur with shell-side no-flow conditions.
  - Preliminary study has determined that solution is feasible
